Natural Heritage Assessment Technical Memos

Technical Memorandum

Subject: **Existing Environmental Conditions and Wetland Impact and Compensation
Assessment for 15th Sideroad Environmental Assessment, Township of King**

Re: **King Township Road Reconstruction Environmental Assessments
10th Concession – Natural Environmental Conditions**

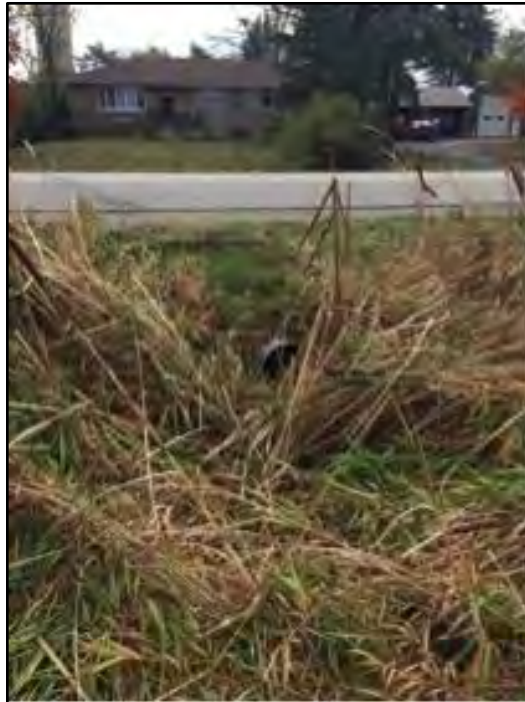
Photo 1. Downstream from north of 15th Sideroad (November 3, 2016).

The upstream site was located along 15th Sideroad (see **Photos 1** and **2**). There was no stream bed material present and there was no source of woody material or leaf litter. North of 15th Sideroad, the drainage flow and culvert were dry with no evidence of a channel and the area supported a cornfield. South of 15th Sideroad at the upstream site (see **Photos 3** and **4**) the culvert was located in front of a residential property with mowed grass. The culvert and channel were dry but it is evident the drainage feature could have ephemeral flow south of the road into the farm field adjacent to the house. The

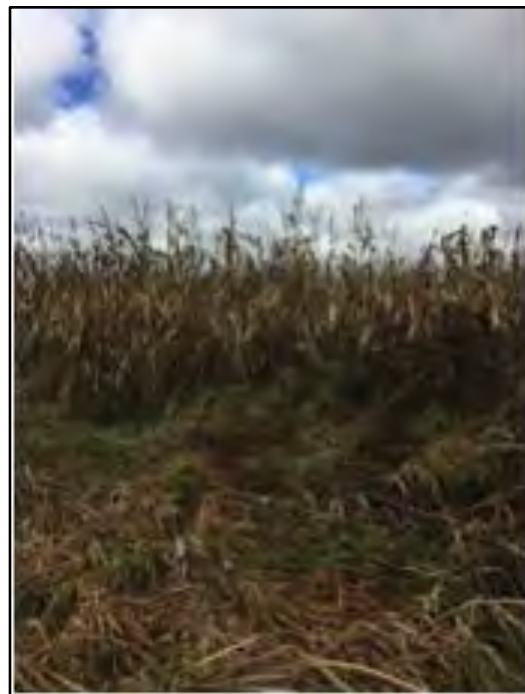
Photo 2. Downstream from north of 15th Sideroad (November 3, 2016).

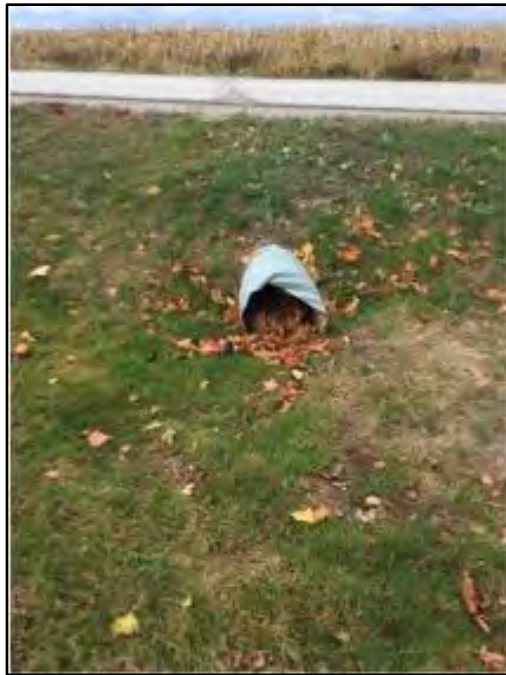
Photo 3. Upstream view from south side 15th Sideroad (November 3, 2016)

channel was also dry during an alternate field visit on June 27, 2016. The drainage feature became evident south of 15th Sideroad in the farm field and was characterized by riparian vegetation consisting of Reed Canary Grass (*Phalaris arundinacea*), Aster sp. (*Aster sp.*), Golden Rod sp. (*Solidago sp.*), and Queen Anne's Lace (*Daucus carota*). A strip of unplowed vegetation on either side of the drainage flow was observed on the farmer's field (Photo 4). The riparian vegetation beside the house consists of Golden Rod sp. (*Solidago sp.*), Reed Canary Grass (*Phalaris arundinacea*), and Aster sp. (*Aster sp.*).

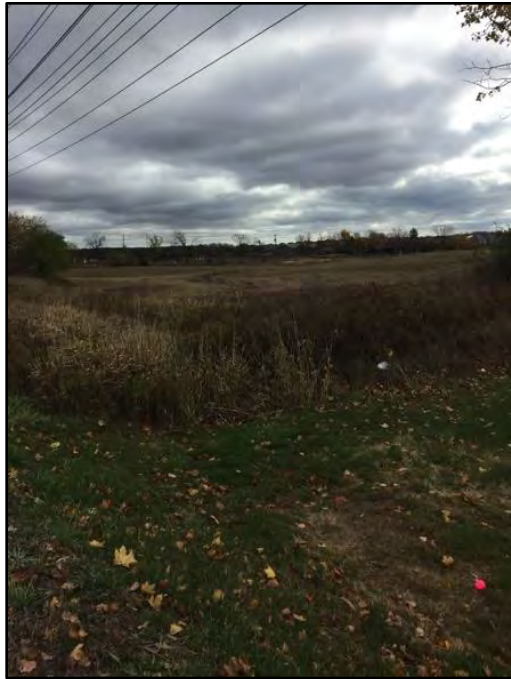
Photo 4. Downstream view, south of 15th Sideroad.

The downstream site was located adjacent to the York Region Water tower on Hwy. 27 on the west side of the road. There is a culvert located along Highway 27 by the York Region Water tower access road (see **Photo 5**). There was no stream bed material present downstream and there was no source of woody material or leaf litter. At the downstream site, the drainage feature flow and the culvert were dry. The riparian vegetation at the north end of the roadside culvert consisted of Reed Canary Grass (*Phalaris arundinacea*), Grass sp. Cattails (*Typha sp.*), Golden Rod sp. (*Solidago sp.*), and European Common Reed (*Phragmites australis*). The riparian vegetation at the south end of the culvert consisted of the same plant species.

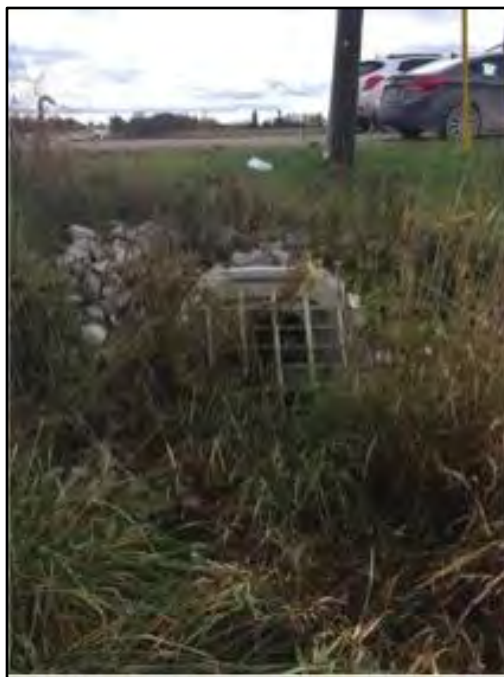
Photo 5. Highway 27, along York Region Water Tower access road, north end of the culvert.

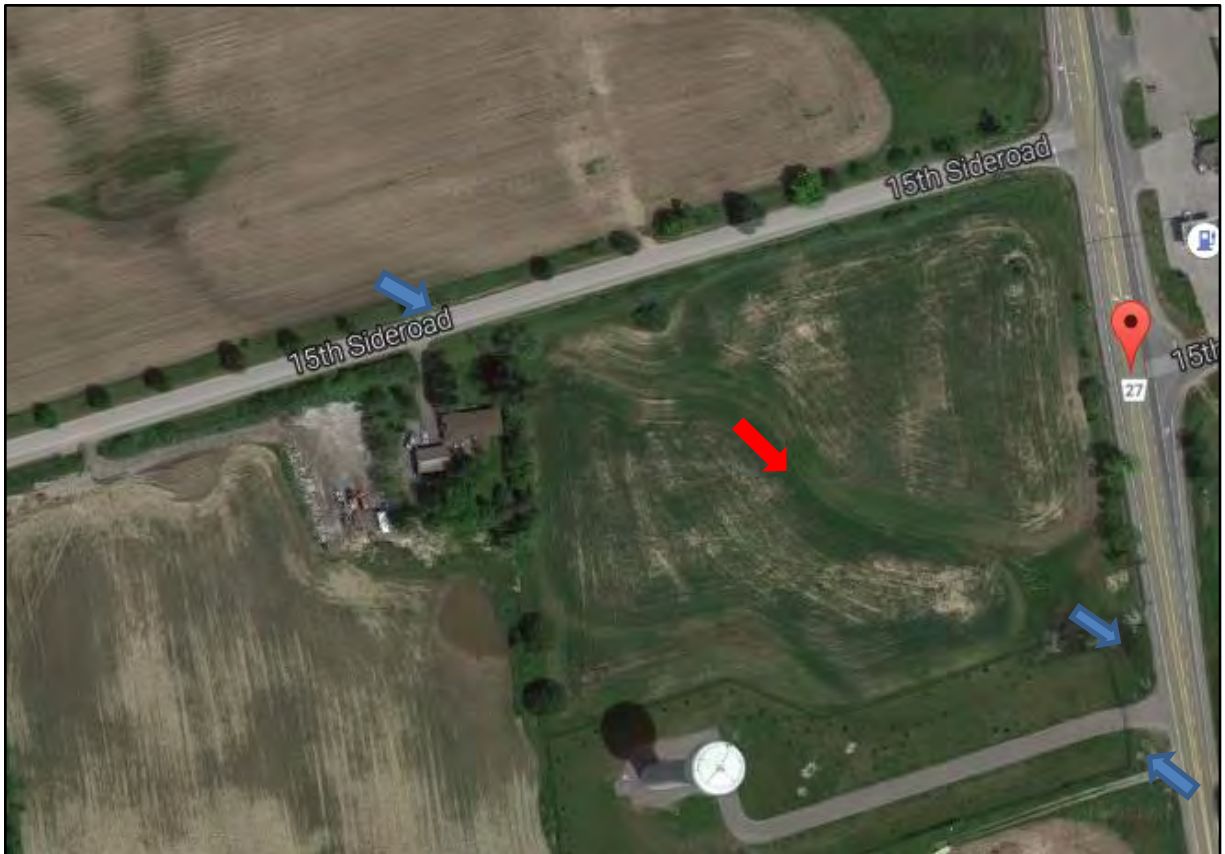
Map C. A Google Earth map of the site illustrating the drainage feature at 15th Sideroad. The culverts are represented by the blue arrows and the red arrow represents drainage flow direction through the field.

The drainage feature is mapped as a watercourse by the Ministry of Natural Resources, however the aquatic assessment indicated that this is a drainage feature. The drainage feature terminated at a roadside ditch along highway 27 adjacent to the water tower. At this location, if there were a flow it would disperse through the culvert and drain into the ditch along the road. There was no stream channel habitat containing stream alluvium, stream bank formation, or evidence of scouring noted. There was no surficial connectivity to downstream aquatic habitat to the Black Duck Wetland Complex.

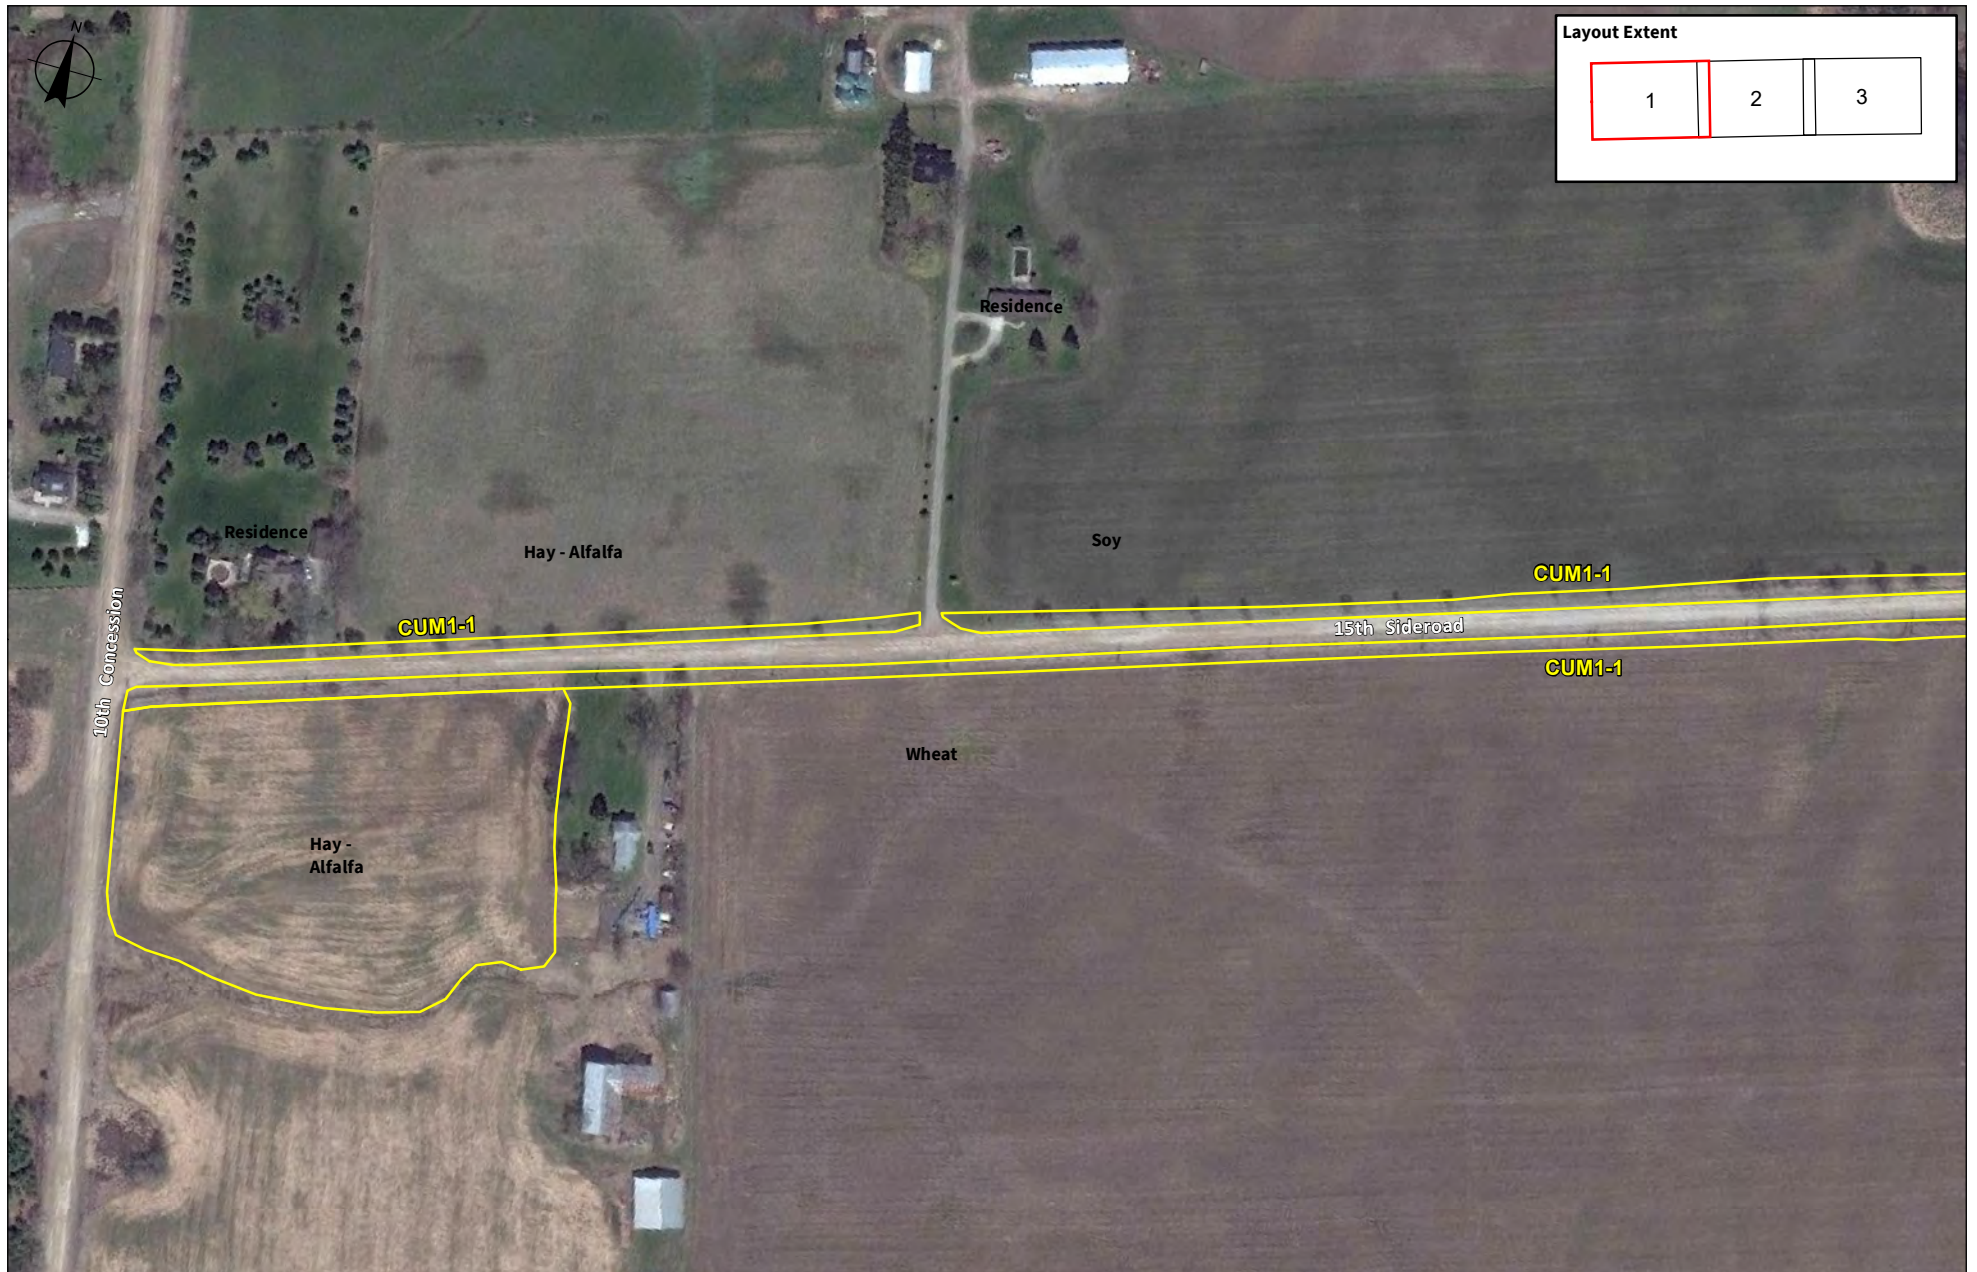
FIGURE 2.1 Existing Conditions

- MAS2-1** Cattail Mineral Shallow Marsh
- SWD6-3** Swamp Maple Organic Deciduous Swamp
- CUM1-1** Dry-Moist Old Field Meadow
- SWT2-2** Willow Mineral Thicket Swamp
- MAM2-2** Reed-canary Grass Mineral Meadow Marsh

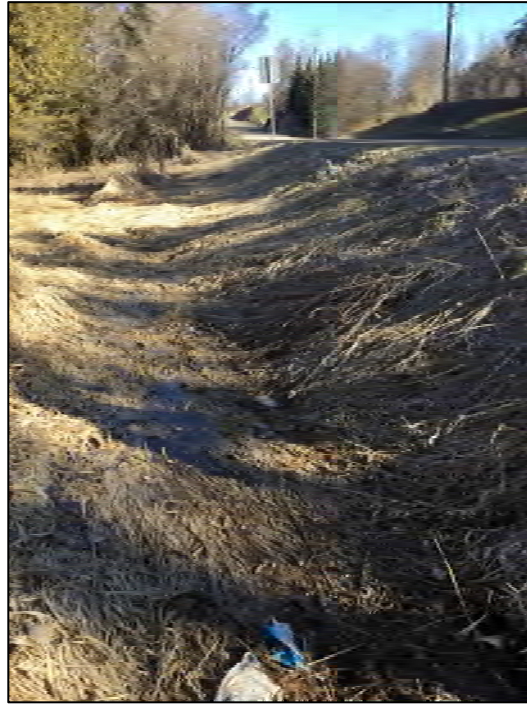
Photo 1: HDF A, facing north (April 3, 2020)

During the HDF surveys on April 3, 2020, two (2) small bird nests were observed near HDF A in the same shrub near the road (**Figure 2**). Another small nest was observed at the edge of the deciduous forest (FOD) on the western edge of HDF G. A nest was observed within the shallow marsh (MAS2) on the west side of Concession 10 across from HDF F. Several Red-winged Blackbird (*Agelaius phoeniceus*) were observed calling and displaying territorial behaviour near HDF I, suggesting potential nests within the wetland feature (MAS2-1).

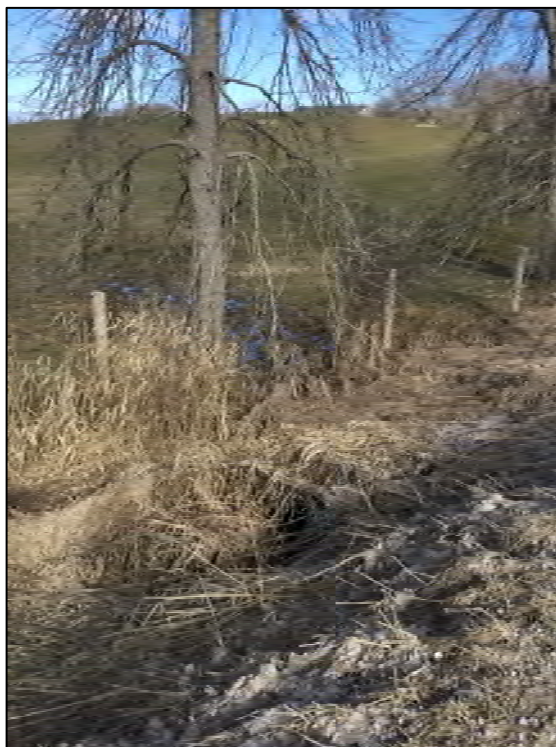
Photo 2: Western portion of HDF B, facing west (April 3, 2020)

This feature is located approximately 60 m north of HDF A, flowing east to west underneath Concession 10. Seepage was observed around the eastern culvert, spanning approximately 3 x 3 m. A moderate flow was observed during the April 3, 2020 visit. The culvert is 0.5 m in diameter and was unobstructed during the April survey. The standing water was 0.03 – 0.06 m deep. The feature bottom was completely vegetated with grass and leaf litter (**Photo 2**). The wetted width was 0.35 – 1.1 m. It is assumed to provide nutrient contribution to downstream fish habitat. Downstream of 10th Concession the flow became a slow trickle to standing water and the depth was about 0.04 m deep with a wetted width of 0.8 m which widens past the at the edge of the right-of-way. Riparian vegetation was comprised completely of Reed Canary Grass both upstream and downstream of the feature. Some woody debris was partially obstructing the west side of the culvert. This feature was observed to be flowing during the June 7, 2019 site visit, however, was dry during the July 23, 2019 site visit.

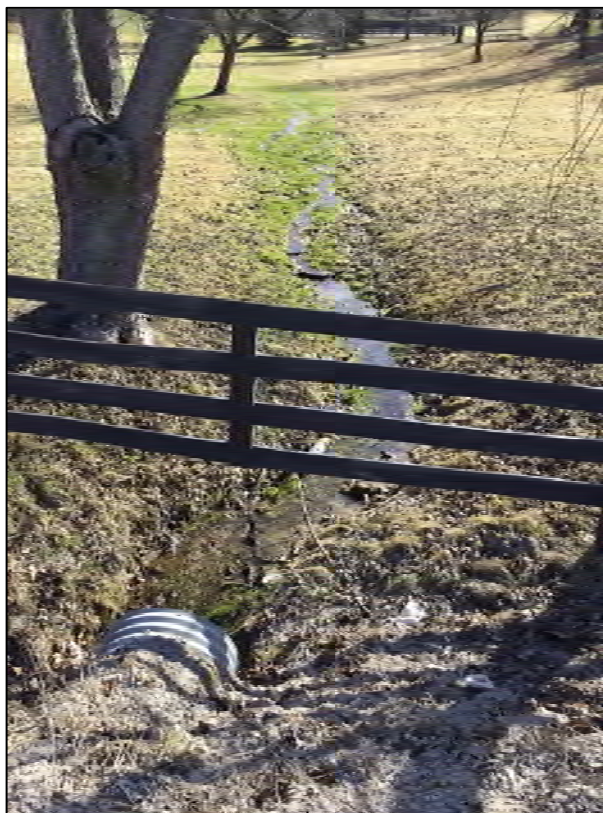
Photo 3: HDF C, facing east (April 3, 2020)

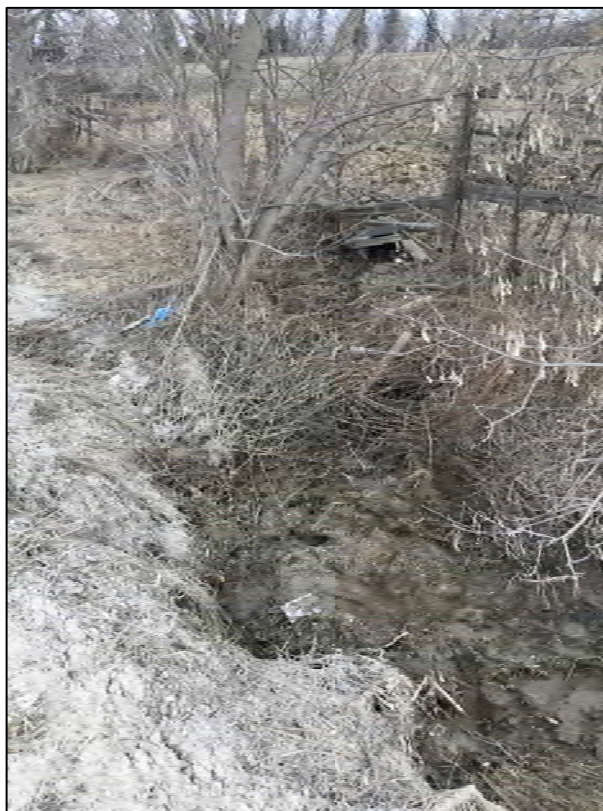
Photo 4: Eastern portion of HDF D, facing east (April 3, 2020)

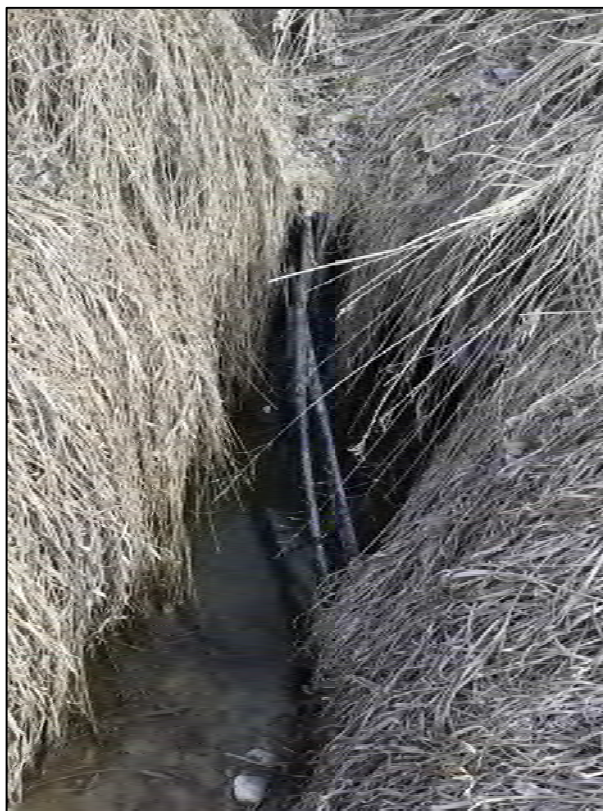
Photo 5: Exposed cables at HDF E, facing northeast (April 3, 2020)

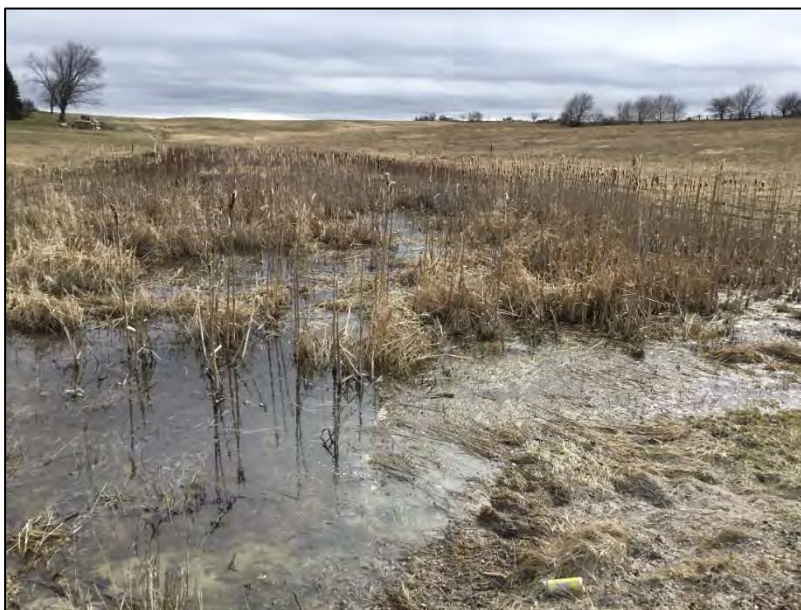
Photo 6: HDF F, facing east (April 3, 2020)

This feature, located approximately 400 m north of HDF E, has a 0.5 m diameter culvert with marsh vegetation (Reed Canary Grass and cattail) comprising the riparian vegetation. There is no defined channel through the shallow marsh (MAS2) with the width of the marsh supporting standing water observed to be 0.1 m deep feature (**Photo 6**). A small portion of the culvert was blocked with sediment build-up. This feature drains into the shallow marsh west of Concession 10 containing Reed Canary Grass and Red-osier Dogwood (*Cornus sericea*) where no standing water was present. Standing water was observed at this feature during the June 7, 2019 site visit, however, was dry during the July 23, 2019 site visit.

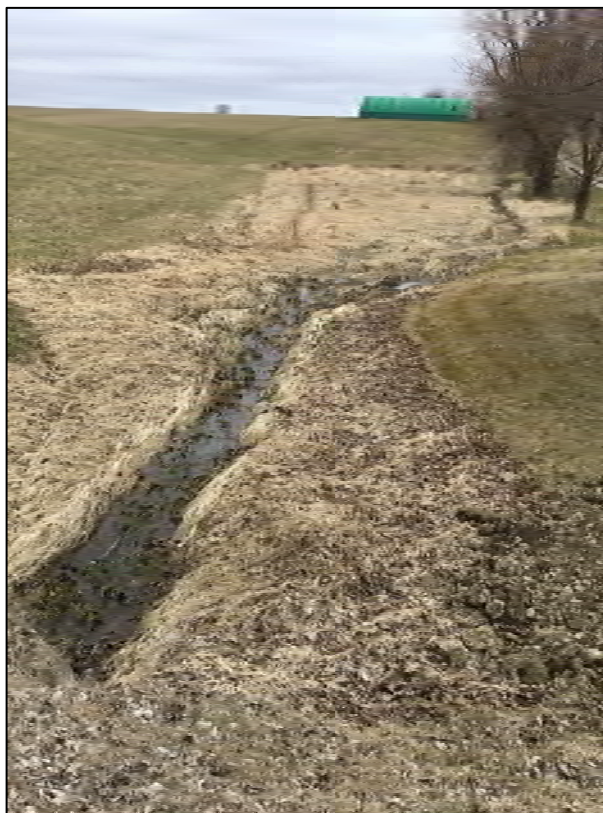
Photo 7: Eastern portion of HDF G, facing east (April 3, 2020)

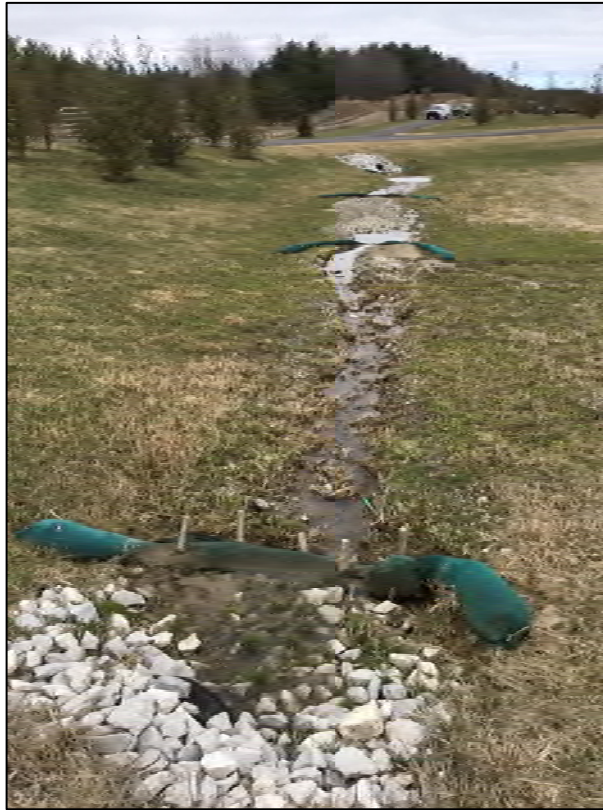
Photo 8: Western portion of HDF H, facing west (April 3, 2020)

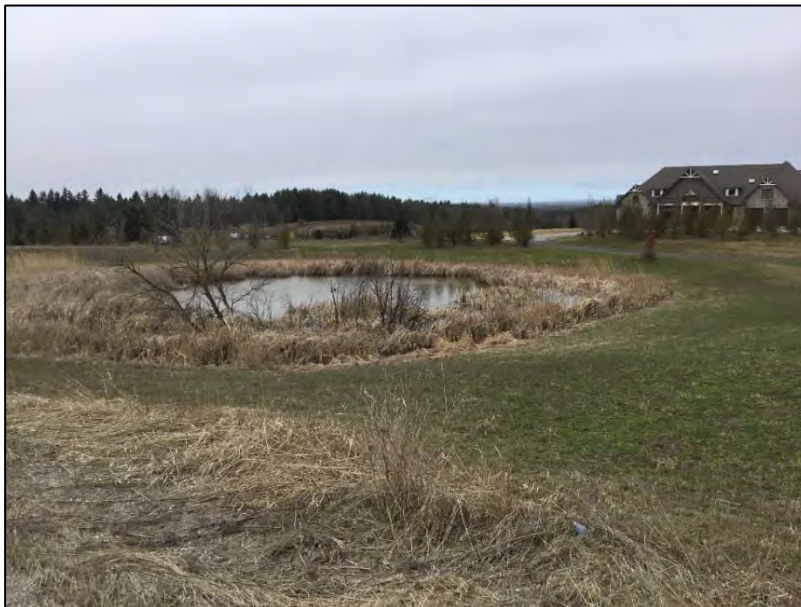
Photo 9: HDF I, facing west (April 3, 2020)

This feature is located at and arising from the shallow marsh pond (MAS2-1) at the intersection of 10th Concession and 15th Sideroad. There is no drainage channel that crosses 10th Concession. The width of the open water shallow marsh is approximately 50 m and likely a few metres deep. Approximately 10 m of cattail riparian vegetation surrounds this marsh, further surrounded by mowed lawn. Furthermore, a berm surrounds the western edge of this feature. Natural heritage online mapping had indicated connection of the HDF to the shallow marsh, however, this connection seems to have been removed. Water was observed in the pond during all site visits on June 7 and July 23, 2019 and April, 2020.

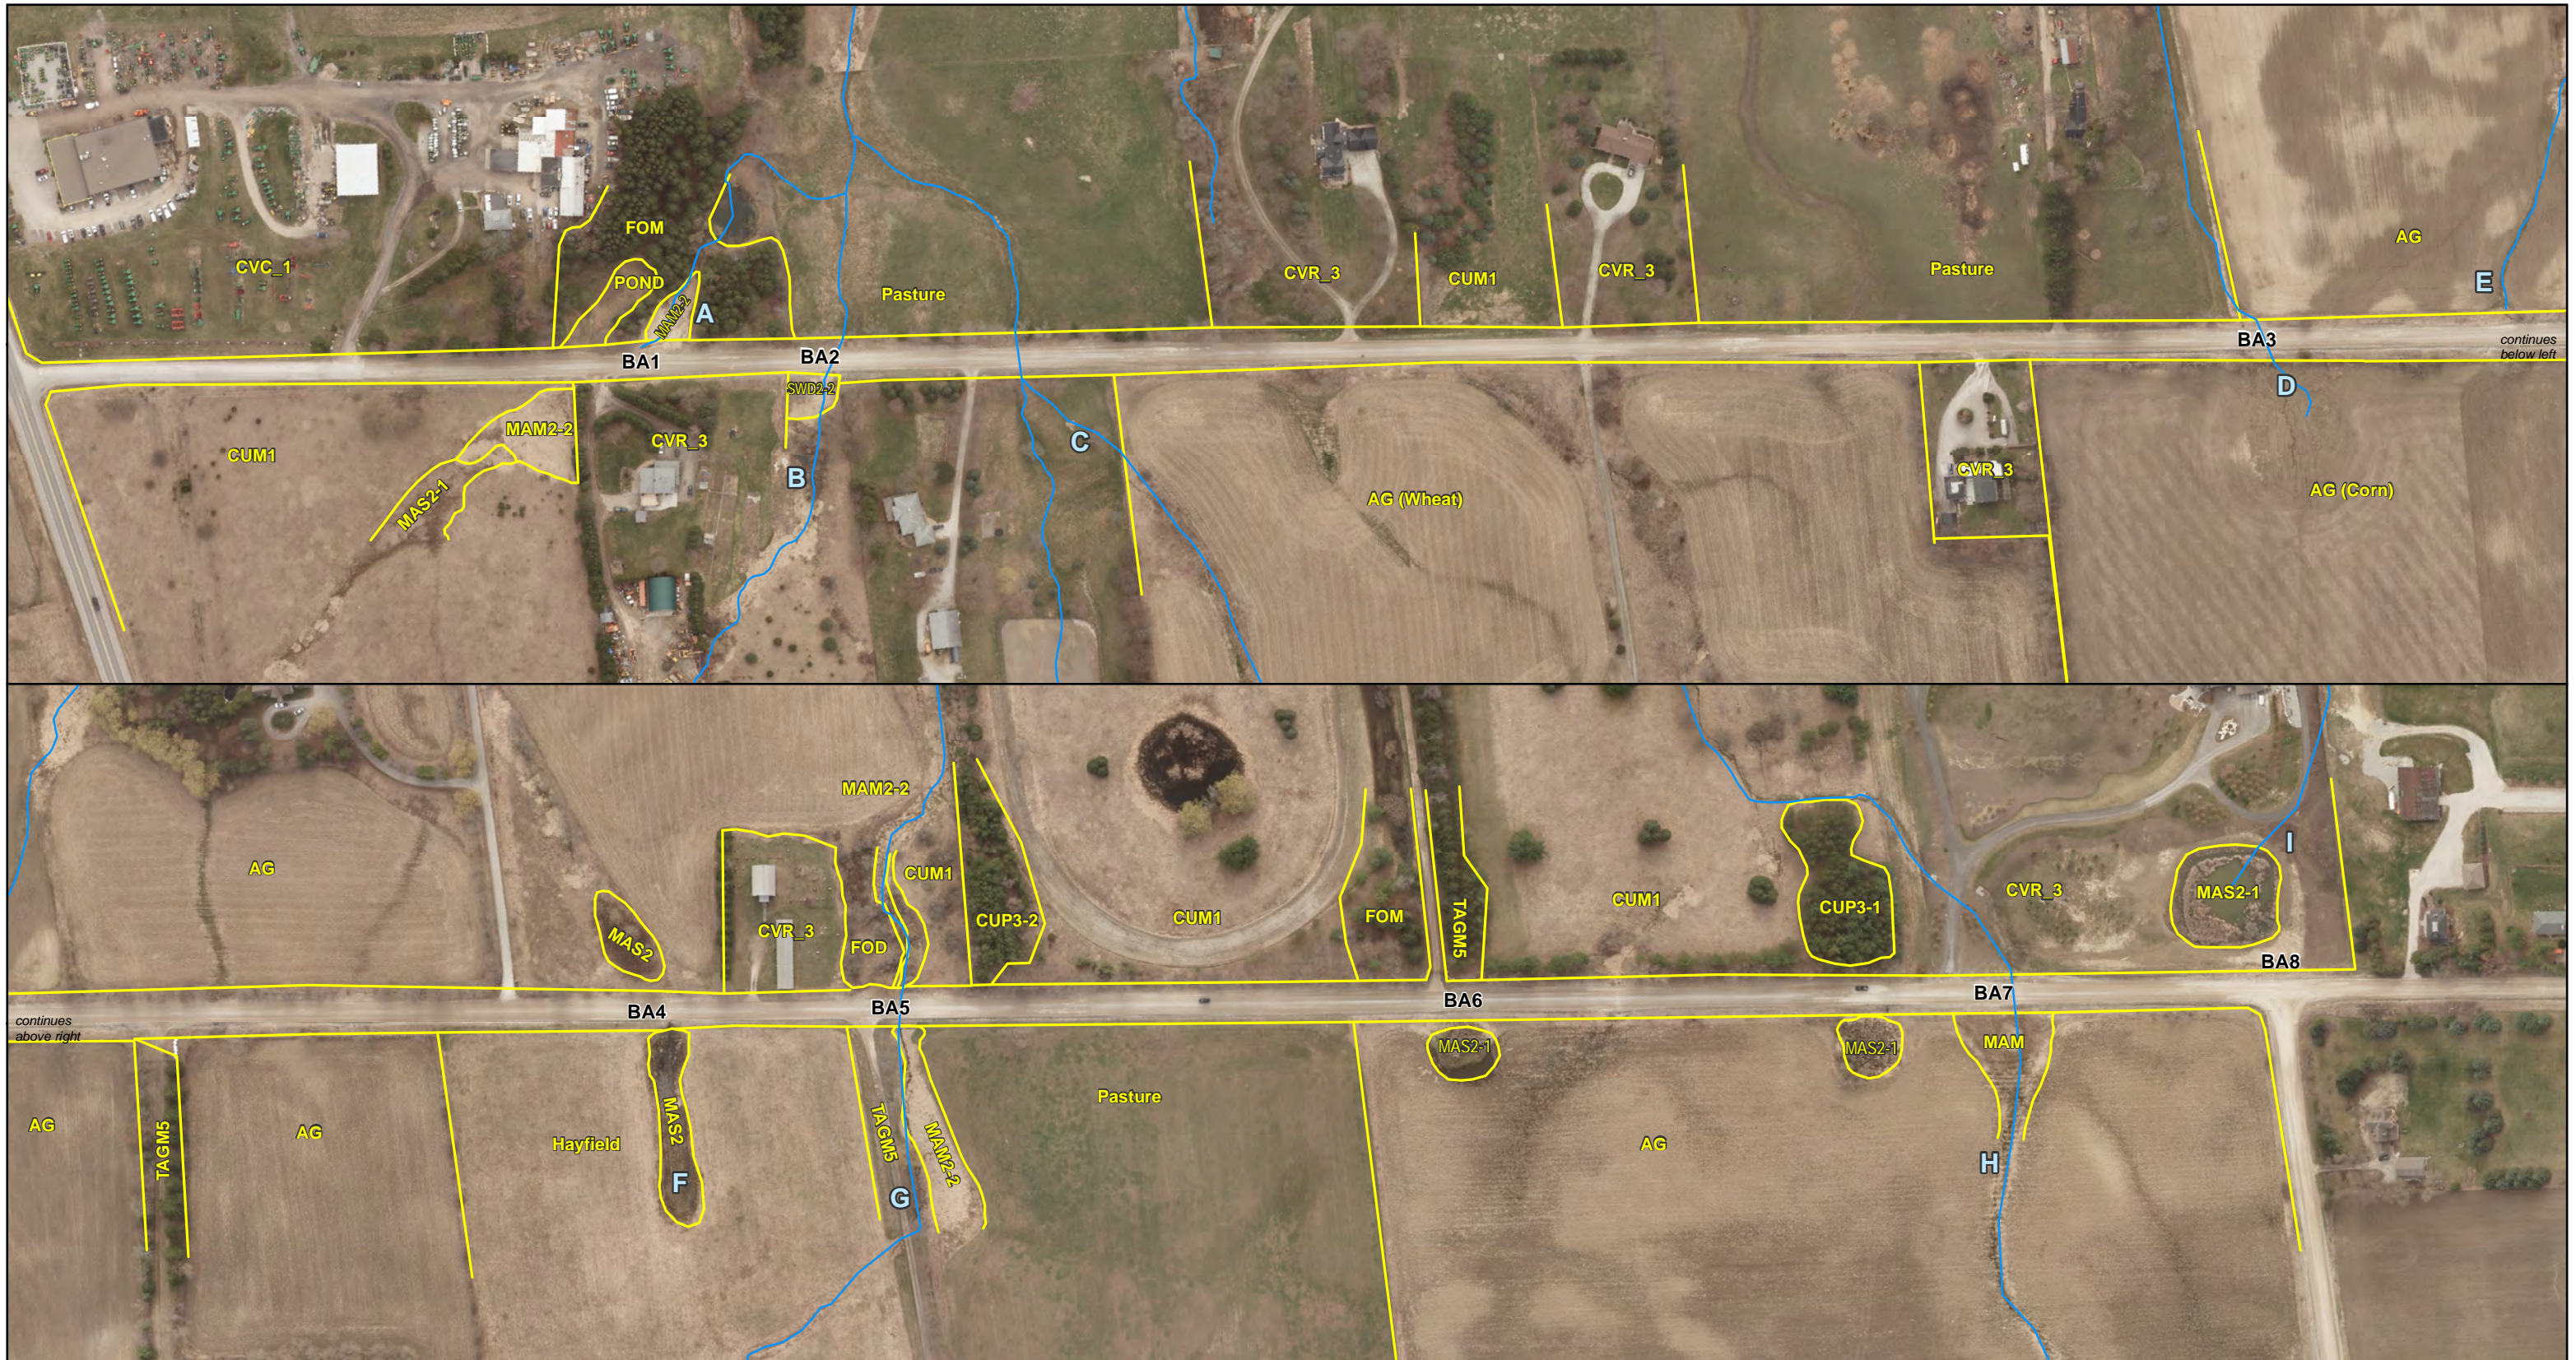
Figure 2

- LEGEND:
- A** Headwater Drainage Feature (HDF)
 - Watercourse (TRCA)
 - ELC Community
 - BA1** Breeding Amphibian Survey Station
- Terrestrial System*
FO (Forest)
FOD: Deciduous Forest
- CU (Cultural)
CUM1: Mineral Cultural Meadow
CUP3-1: Red Pine Coniferous Plantation Type
CUP3-2: White Pine Coniferous Plantation Type
TAGM5: Fencerow
AG: Agricultural
- CV (Constructed)
CVC_1: Business Sector
CVR_3: Single Family Residential
- Wetland System*
MA (Marsh)
MAM2-2: Reed-canary Grass Mineral Meadow Marsh
MAS2: Mineral Shallow Marsh
MAS2-1: Cattail Mineral Shallow Marsh
- SW (Swamp)
SWD2-2: Green Ash Mineral Deciduous Swamp Type

Based on the *Evaluation, Classification and Management of Headwater Drainage Features Guidelines*, no drainage features in the Study Area are permanent streams. Rather, all of the drainage features are considered intermittent or ephemeral. Additional information about the terrestrial features near the HDFs are provided in **Figure 2** and in **Section 4.1**.

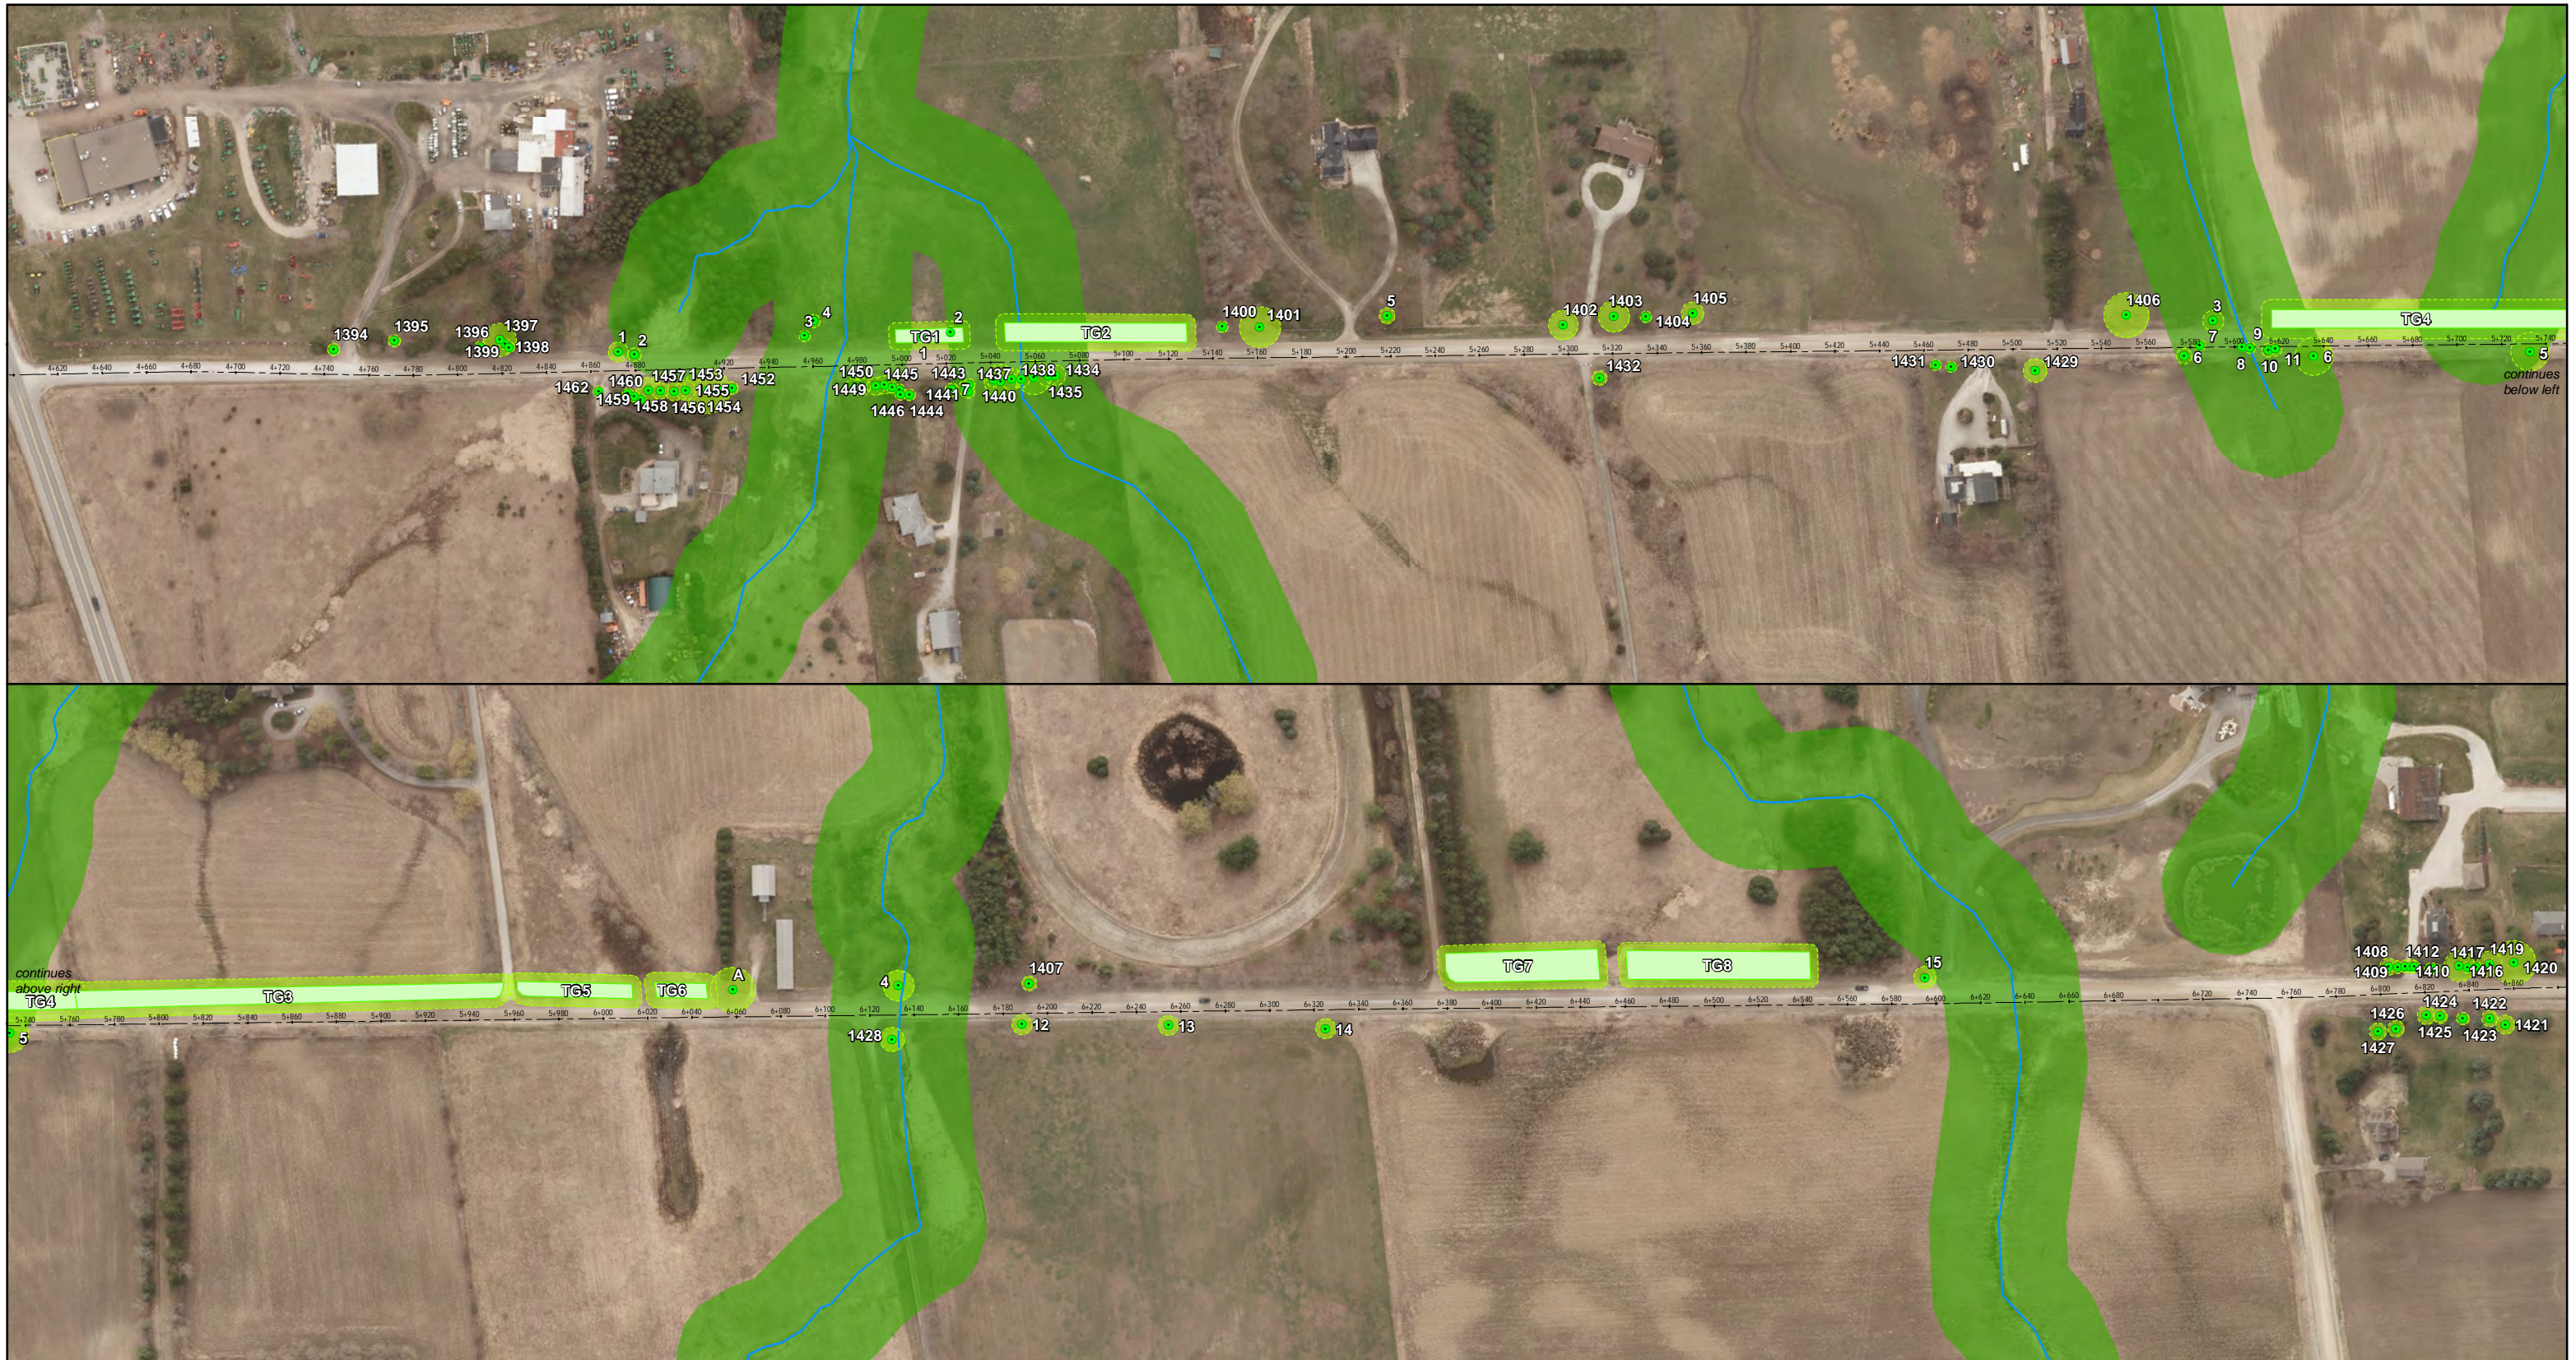
Figure 3

- Inventory Tree
- Tree Protection Zone
- ⊕ Tree Grouping
- Watercourse (TRCA)
- TRCA Regulation Limit

The tree inventory comprised 190 individual trees, including 151 (79%) native and 32 (17%) non-native species, as well as 7 (4%) trees identified to the genus level or lower (**Table 2**). There were no Species at Risk (SAR) trees observed, such as Butternut. The full tree inventory is provided in **Appendix A**. The locations of inventoried trees are shown on **Figures 3**.

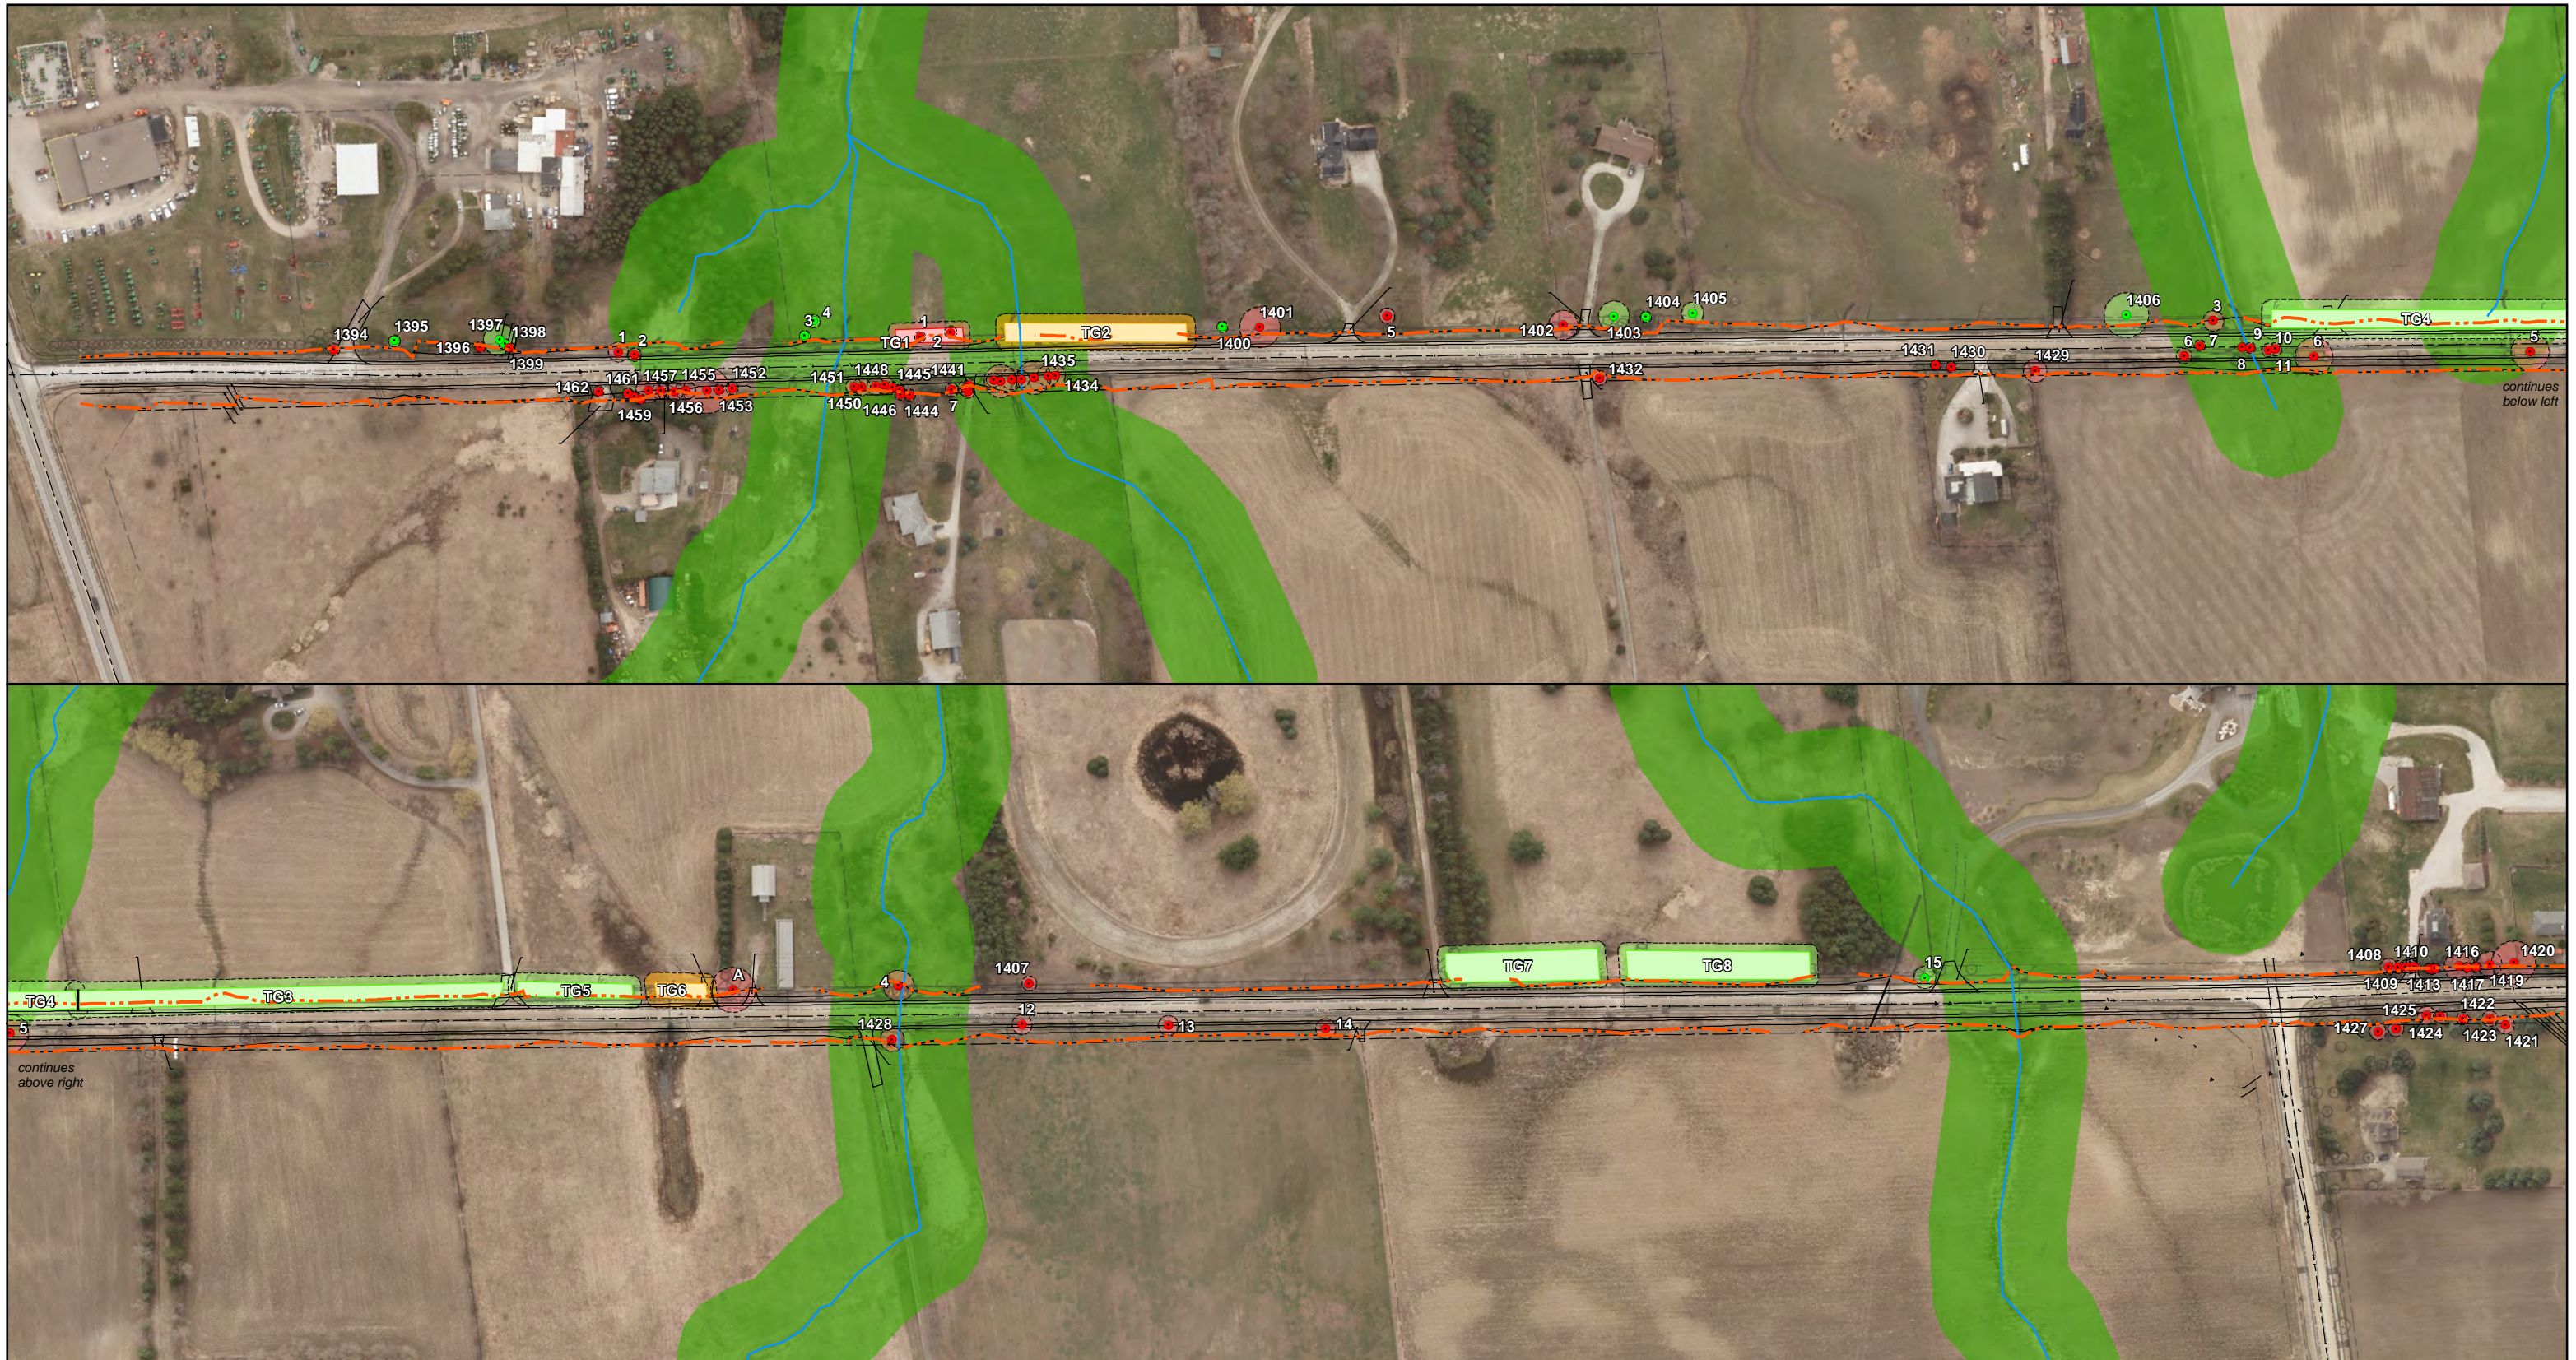
Figure 5

- Tree to be Retained
- Tree Expected to be Injured (Potentially Retainable)
- Tree to be Removed

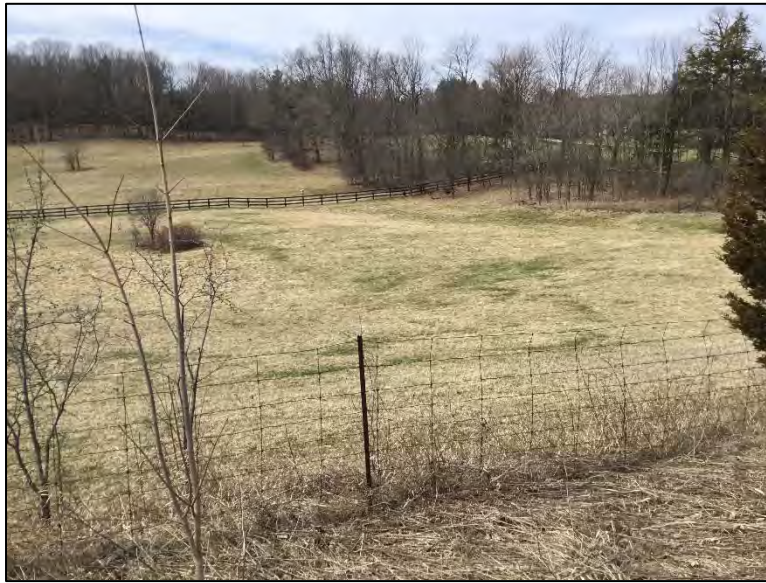
Photo 1: HDF J, facing west (April 3, 2020)
