Natural Heritage Assessment Technical Memos

Technical Memorandum

Subject: **Existing Environmental Conditions and Wetland Impact and Compensation
Assessment for 15th Sideroad Environmental Assessment, Township of King**

Re: **King Township Road Reconstruction Environmental Assessments
10th Concession – Natural Environmental Conditions**

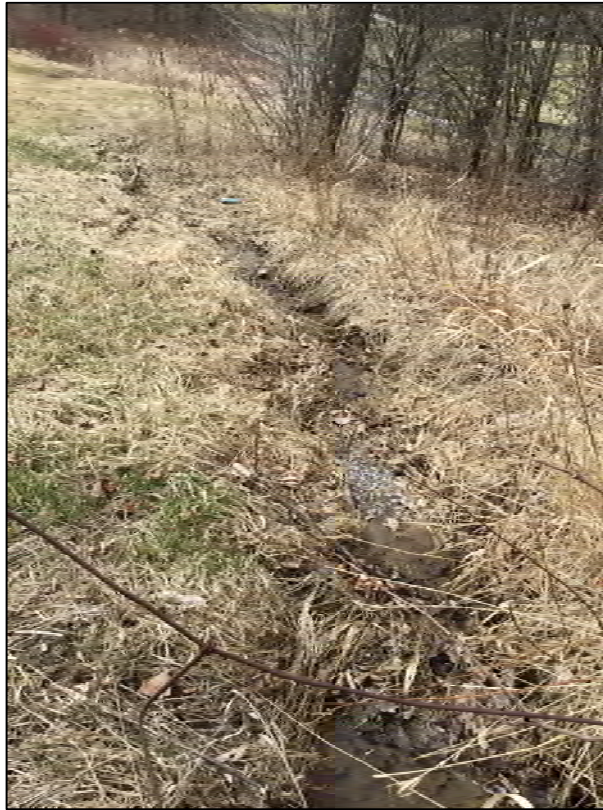
Photo 2: HDF K, facing west (April 3, 2020)

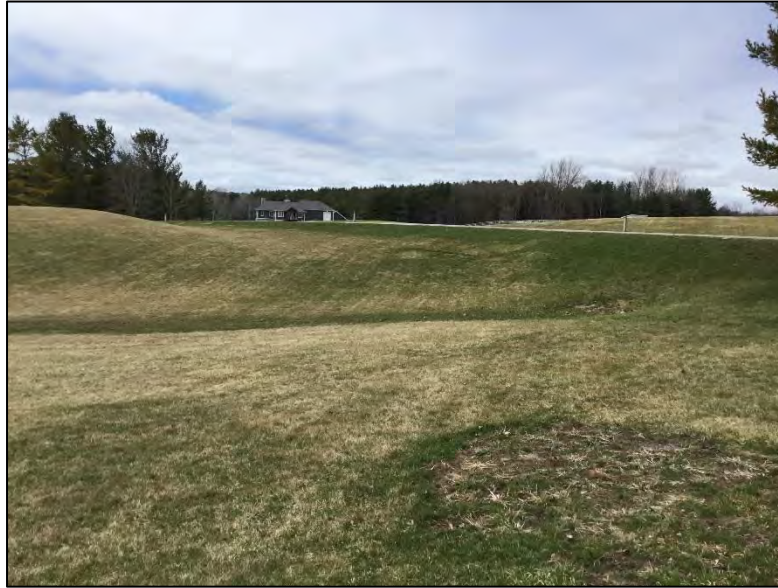
Photo 3: HDF L, facing west (April 3, 2020)

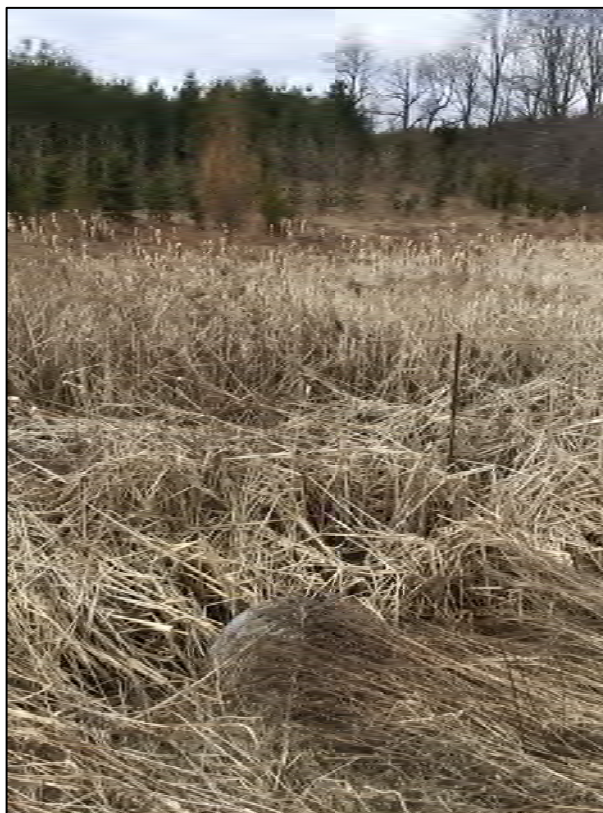
Photo 4: Western portion of HDF M, facing west (April 3, 2020)

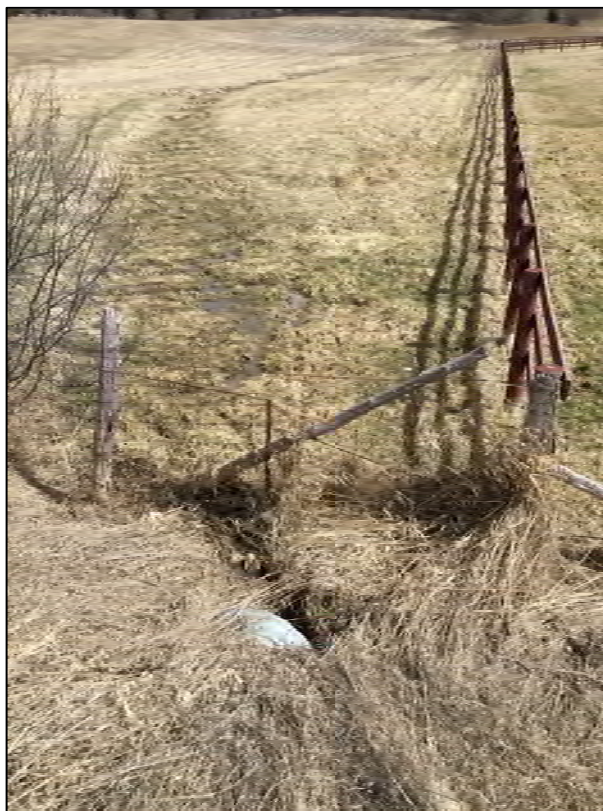
Photo 5: Eastern portion of HDF N, facing east (April 3, 2020)

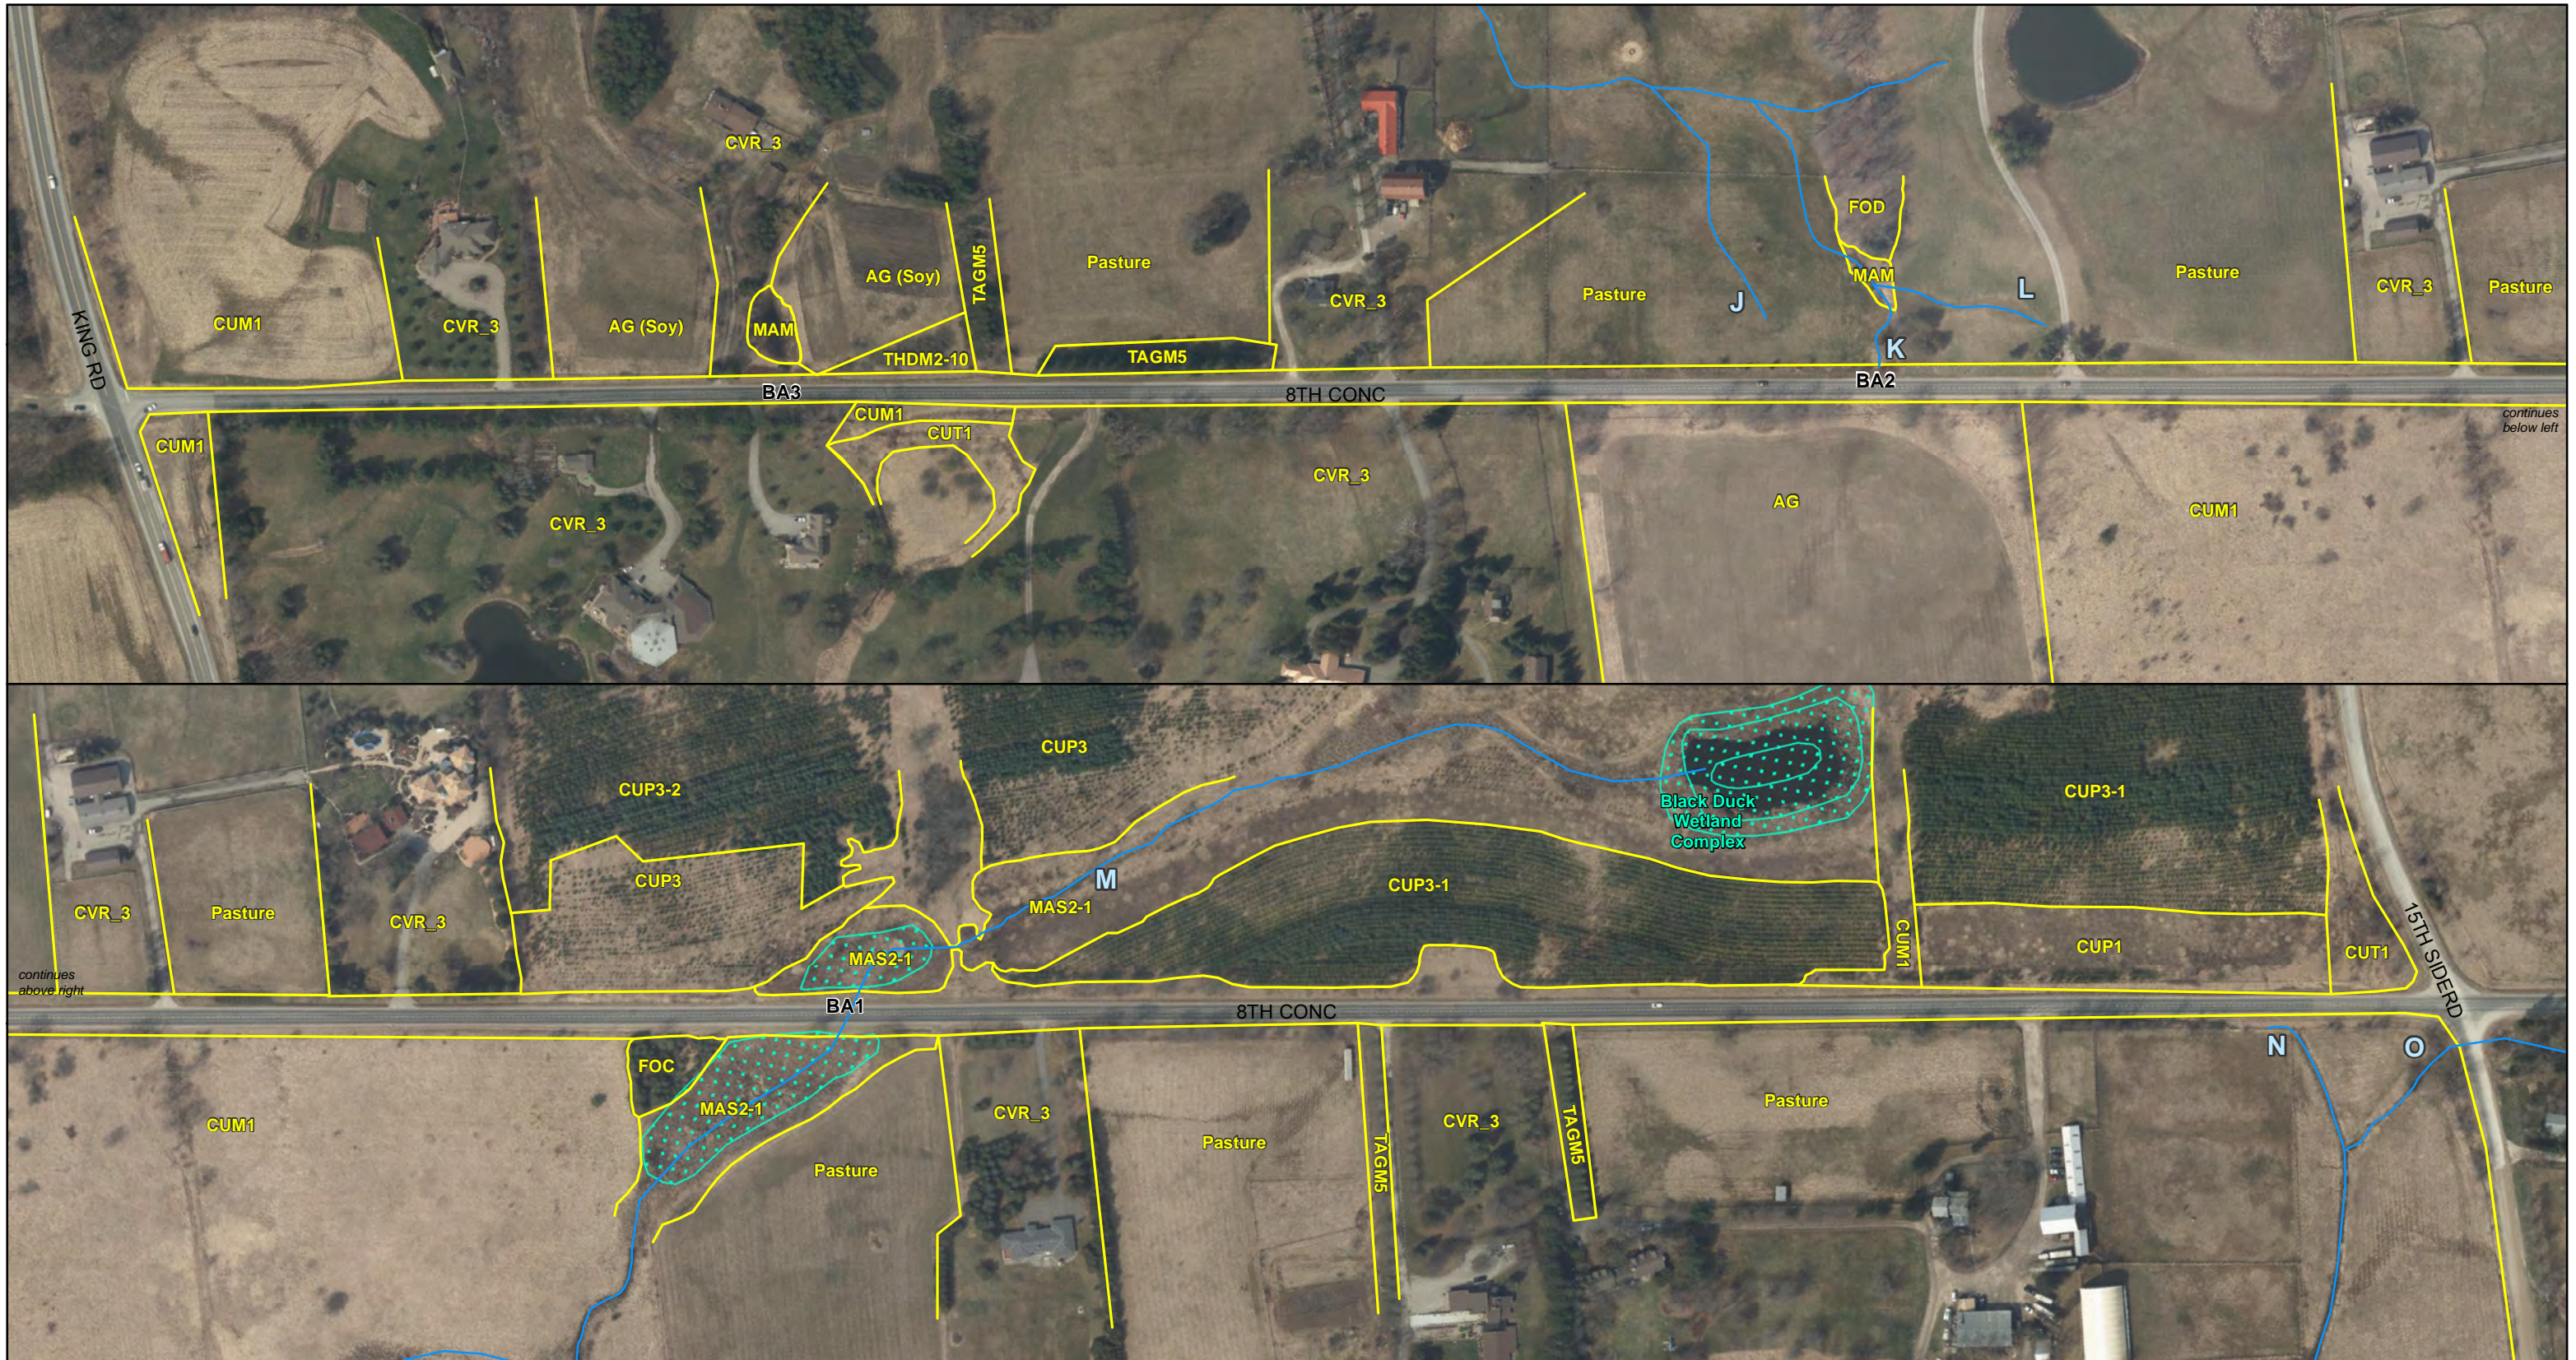
Figure 2

- LEGEND:
- Headwater Drainage Feature (HDF)
 - Watercourse (TRCA)
 - ELC Community
 - Wetland - Evaluated-Provincial
 - BA1 Breeding Amphibian Survey Station
- Terrestrial System**
- FO (Forest)
 - FOD: Deciduous Forest
 - FOC: Coniferous Forest
 - CU (Cultural)
 - CUM1: Mineral Cultural Meadow
 - CUP1: Deciduous Plantation
 - CUP3: Coniferous Plantation
 - CUP3-1: Red Pine Coniferous Plantation Type
 - CUP3-2: White Pine Coniferous Plantation Type
 - CUT1: Mineral Cultural Thicket
- Wetland System**
- MA (Marsh)
 - MAS2-1: Cattail Mineral Shallow Marsh
- Other Land Use**
- TAGM5: Fencerow
 - AG: Agricultural
 - TH (Thicket)
 - THDM2-10: Apple Deciduous Shrub Thicket Type
 - CV (Constructed)
 - CVR_3: Single Family Residential

Based on the *Evaluation, Classification and Management of Headwater Drainage Features Guidelines*, no drainage features in the Study Area are permanent (perennial) streams. Rather, all of the drainage features are considered intermittent or ephemeral. Additional information about the terrestrial features near the HDFs are provided in **Figure 2** and in **Section 4.1**.
